# DRAG PREVENTION COATINGS

## for marine propellers

This paper presents some results of the research being conducted into the use of silicone based foul release coatings to prevent the increases in roughness and hence drag, caused by fouling on marine propellers in service. It explores previous research conducted within the School of Marine Science and Technology at Newcastle University into the hydrodynamics of Foul Release coatings.

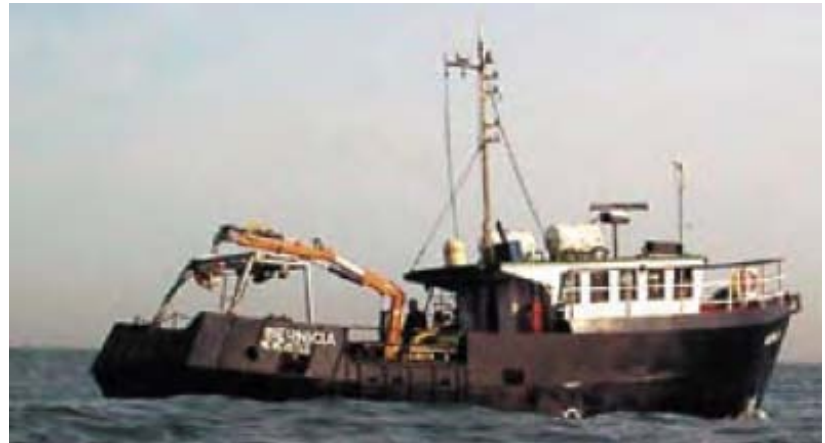
Figure 2: The Research vessel 'Bernicia'.

Diameter	1.14m
Blade area ratio	0.466
Number of blades	4
Maximum shaft speed rpm	440
Direction of rotation	Right

To investigate the effect of the coating in full scale it was decided to run a series of sea trials over a measured mile. These were conducted with the school research vessel 'Bernicia' (Figure 2), which is a 16m ship based on the design of a fishing vessel and is mainly used for estuarine and coastal research. The general particulars are shown in Table 1 and the propeller details are shown in Table 2. The vessel was used to conduct a series of trial measurements with the propeller uncoated before being placed on the ship and its 1.14m diameter propeller removed to be coated using a silicone based Foul Release marine coating. Another series of measured mile trials was then conducted. Despite the weather affecting the coated trial the results showed little difference between the performance of the coated and uncoated propellers (Figure 3). Detailed results of these trials can be found in (Mutton et al., 2003).

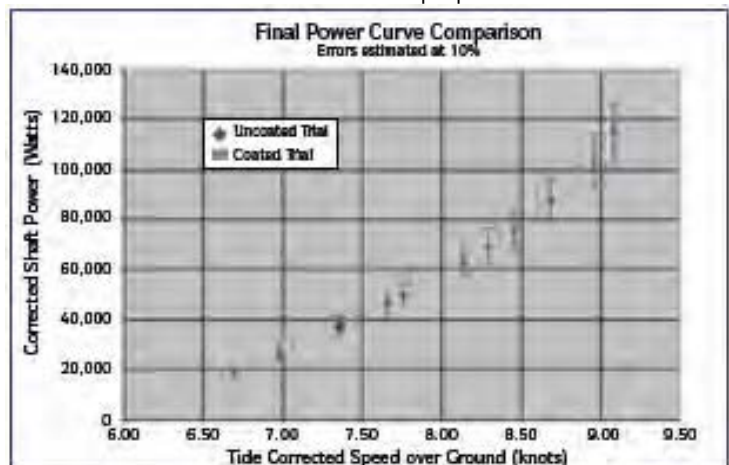
Figure 3: The final results of the 'Bernicia' sea trials show no statistical difference between the two curves. The trials were particularly affected by the weather leading to large error estimates and making the results inconclusive.

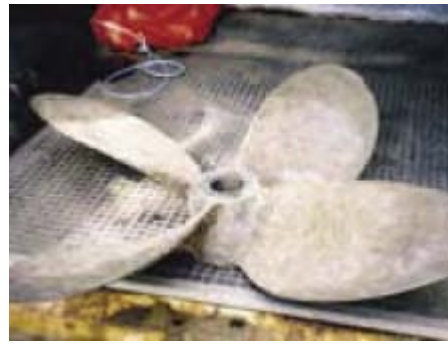
Figure 4: The propeller of 'Bernicia' after 14 months in service before coating. Hard shell fouling is present to half the blade radius.

After a year with the coating in service 'Bernicia' was again docked and the state of the propeller coating inspected (Mutton, 2004). The coating was found to be in good condition with only light slime present on the inner part of the blades. The coating was 95% intact, except slight removal of the coating at the edges of the blades. Figure 4 shows the uncoated propeller after a previous period of 14 months in service. Hard shell fouling, mainly barnacles, was present to about half the blade radius. This can be compared to figure 5 which shows the state of the coated propeller after 12 months in service. During the trials, roughness measurements were taken on the propeller using a 'Surtronic 3 +' roughness gauge before and after the coating was applied. This unit was selected because of its small size and automated traverse

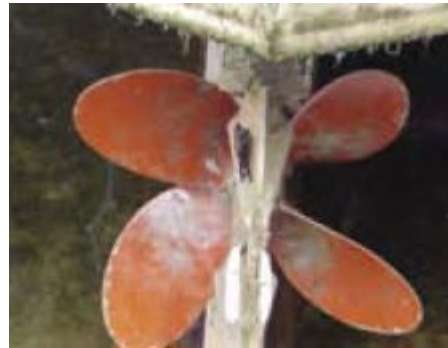
Figure 5: The propeller of 'Bernicia' after 12 months in service after coating. 95% of the coating is intact, except some detachment of the blade edges. Light slime fouling is present in the inner half of the blades (grey material in the red coating is the dried bio film). This could be easily removed by hand or with a damp cloth.

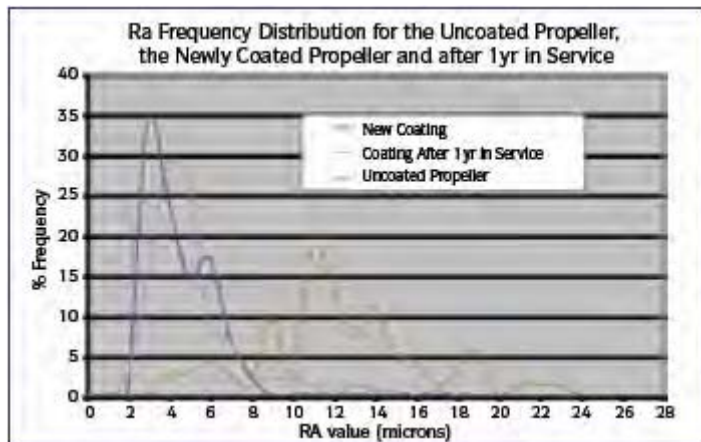
Figure 6: The mean roughness amplitude,  $R_a$  Frequency distributions (with a cut off length of 2.5mm). Measured on the propeller of 'Bernicia' before coating, after coating and after a period with the coating in service.

Figure 6 shows the results for the mean roughness amplitude ( $R_a$ , with a cut-off length of 2.5mm). It can be seen that there is a significant difference between the roughness distribution of the uncoated (roughened slightly after about 8 months in service) and the newly coated propeller.

It can also be seen that the coating does not return to a roughness frequency distribution similar to the uncoated propeller after a period of service with the coating. There

was some measured difference between the newly applied coating and the coating after 12 months in service. This is mostly due to the presence of the slime layer on the blades, which can easily be removed by hand or a damp cloth and mechanical damage to the coating. That slime layers can attach to Foul Release coatings is a known phenomenon (Candries et al, 2003) and their effect on the coating performance is currently being investigated as part of this research project.

Figures 6 and 7 both show that the coating significantly changes the roughness characteristics of the propeller blade surface and that the roughness does not change significantly after 12 months in service.

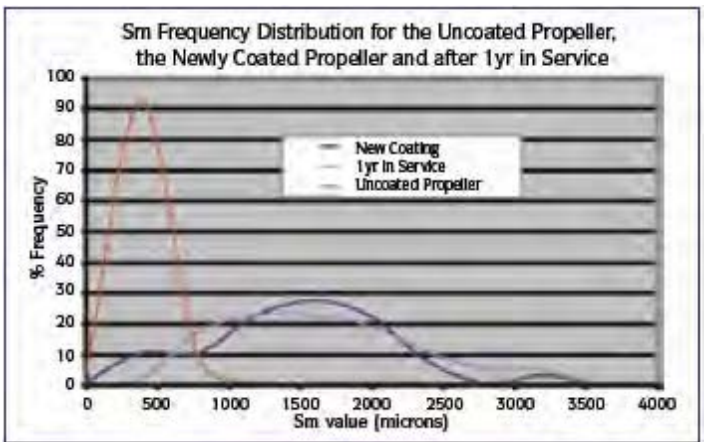
Figure 7: The mean spacing between profile peaks,  $S_m$ , frequency distribution. Measured on the propeller of 'Bernicia' before coating, after coating and after a period with the coating in service.

Figure 7 shows the mean spacing between profile peaks frequency distribution,  $S_m$ , measured on the 'Bernicia's' propeller. This is a measure of the surface texture where the larger the value, the more 'open' the texture. It shows a significant difference between the uncoated and newly coated propeller. The coated propeller exhibits a much wider range of mean spacing, where the uncoated propeller had a much smaller range.

After a period of the coating being in service the frequency distribution of  $S_m$  has changed little and still exhibits the wider range. In a similar manner to the  $R_a$  distribution. In Figure 6 the mean spacing distribution is still fundamentally different to the uncoated propeller distributions after a period of service.

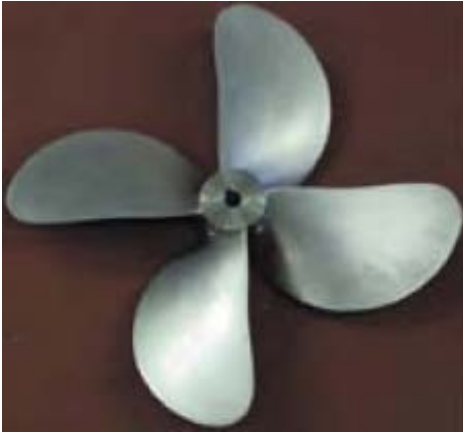
Figure 9: The model propeller with uncoated blades.

The particulars of the model can be seen in Table 4. The uncoated and coated propeller model can be seen in figures 9 and 10 respectively.

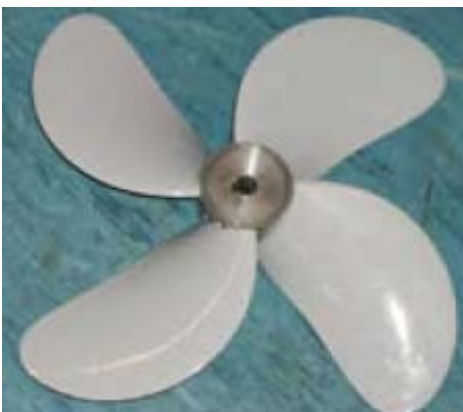
Figure 10: The model propeller with mated blades.

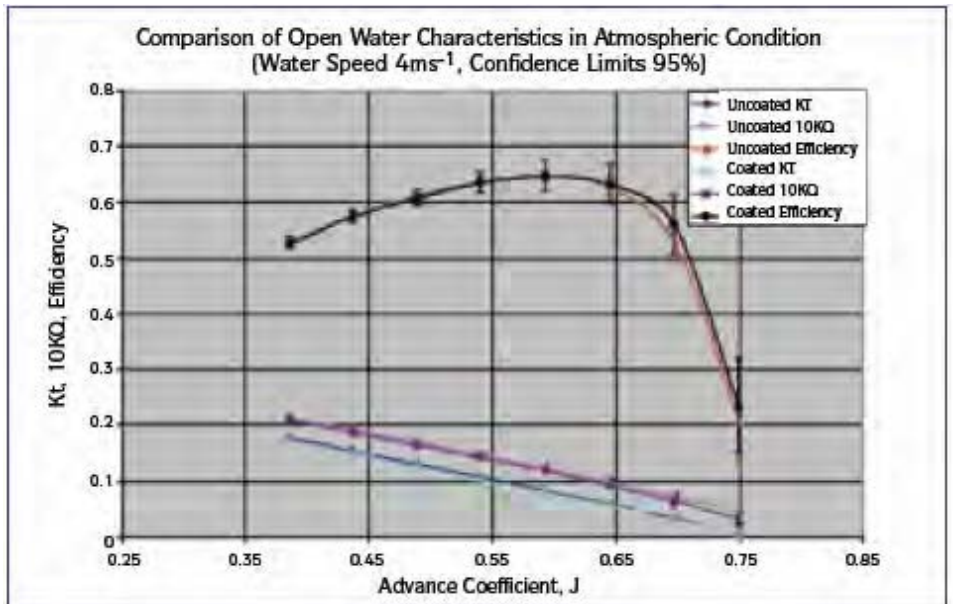
Figure 11 : Thrust torque and efficiency in the atmospheric condition.

The propeller was first tested in atmospheric conditions (no vacuum applied to the tunnel). The tests were conducted at a water speed of 4ms<sup>-1</sup>. This water speed is used as it is fast enough to mitigate Reynolds number effected (the propeller Reynolds number varies between 1x10<sup>6</sup> and 2.5 x 10<sup>6</sup> depending on the rpm. but still allows small advance coefficient (J) values to be achieved within the loading limits of the dynamometer and the propeller motor drive system. The results can be seen in Figure 11.

The results show a slightly higher efficiency for the coated propeller than the uncoated one at the higher advance coefficient values, although the difference between the two lies with the range of experimental accurate of the tests. It does however appear to confirm the results of the computer simulations, that the coated blades have the same drag as new or well polished blades. The slight change in the efficiency is due to the slight decrease in the measure torque values as applied in the computer simulations mentioned earlier.

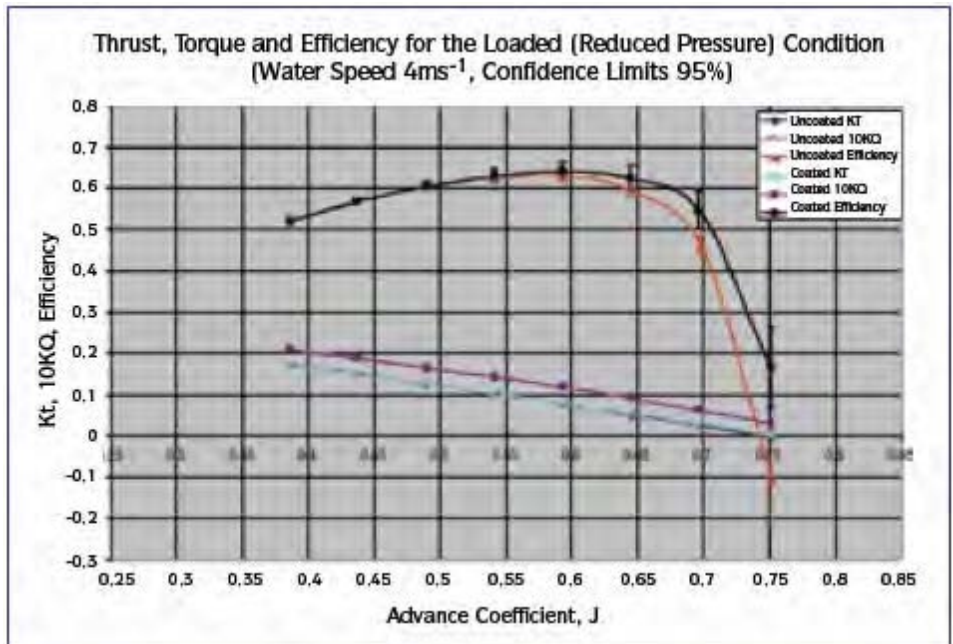
Figure 12: Thrust, torque and efficiency in the loaded (reduced pressure) condition,

A vacuum was then applied to the tunnel in order to scale the pressure, and hence the cavitation effect to the equivalent values for the full scale fully loading condition. The cavitation number at  $\sigma$  70% of the blade radius,  $\sigma = 0.498$ . Figure 12 shows similar results to the tests run in atmospheric conditions. There is some evidence of minor efficiency gains at higher  $J$  values with the coated blades but not sufficient evidence to say that the coating produces a drag reduction effect at anything but the highest values of advance coefficient (corresponding to low values of rpm). The coating again gives the same efficiency at the operating condition as the uncoated propeller (operating point is  $J = 0.48$ ).

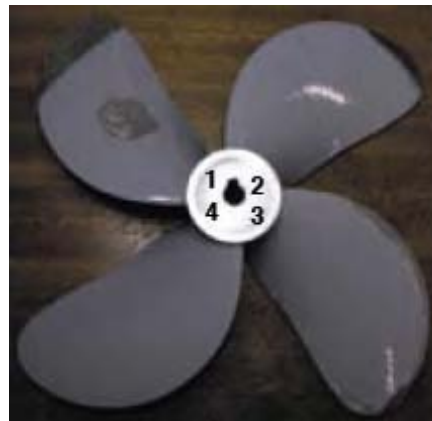
Figure 14: Damage Scenario 2 [view from the back].

Blade 1: Large coating detachment In centre, back of blade.  
Blade 2: Scratched to remove coating, back of blade.  
Blade 3: Damage extended to remove leading and trailing edge, back of blade.  
Blade 4: Left intact as a reference blade.

The second damage condition builds on the first to represent further damage that is possible on the blades. Blade 1 has a large area of the coating removed. The amount removed is considered a worst case scenario of severe impact damaged to the coating and is more extensive than that yet seen on a full scale application. Blade 2 had a number of scratches and abrasions inflicted upon the coating on the back of the blade.

This is typical full scale damage usually caused by foreign bodies impacting on the propeller. They were studied carefully to determine what types of damage and where will have the most impact upon the cavitation pattern of the propeller blade. Blade 3 has had the coating removed along the leading and trailing edges of the back of the blade. This is typical of damage that is often seen in full scale propellers. Blade 4 was again left intact to act as a controller the other three blades. This is seen in Figure 14.

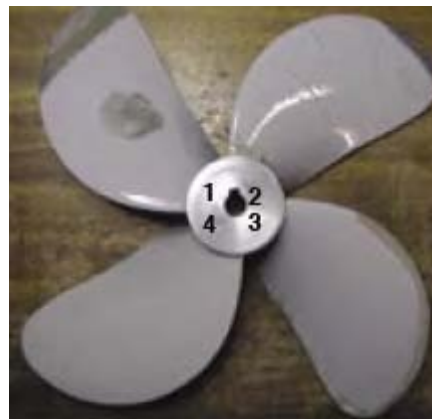
Figure 15: Damage Scenario 3 [view from the back].

- Blade 1: As stage 2 but repeated on the blade face
- Blade 2: As stage 2 but repeated on the blade face, more scratches to back.
- Blade 3: As stage 2 but repeated on the face
- Blade 4: Left intact as a reference blade.

The third scenario of damage test repeated the damage, inflicted upon the back of the blade during scenario 2, to the face of the blades. In addition more scratches and abrasion were inflicted upon the back of Blade 2. The root of Blade 2 on both the back and the face were abraded to simulate the damage to the coating that occurs due to a rope or chain being wrapped around the propeller. The face of Blade 1 has a similar large detachment to that inflicted upon the back of the blade in damage scenario 2. It is however larger and extends closer to the leading edge. The face of Blade 2 has a number of scratches and abrasions. They are concentrated towards the leading edge of the blade as this is an area that was identified in the earlier tests as being most susceptible to cavitation when damaged. The face of Blade 3 has the leading and trailing edges removed in a similar manner to the damage inflicted on the back of the propeller: Blade 4 is again left as a reference with which to compare the previous blades. This is shown in Figures 15 and 16. From Figure 17 it can be seen that only damage scenario 3 shows any significant difference from the intact coating at tile operating advance coefficient. Damage scenario 1 would actually appear to improve the performance slightly. This is most likely due to the removal of the coating, thereby thinning the apparent blade section

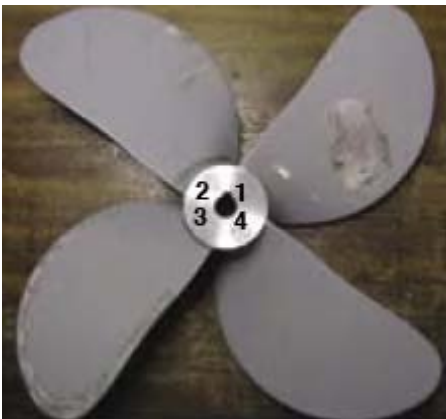
Figure 16: Damage Scenario 3 [view from the face].

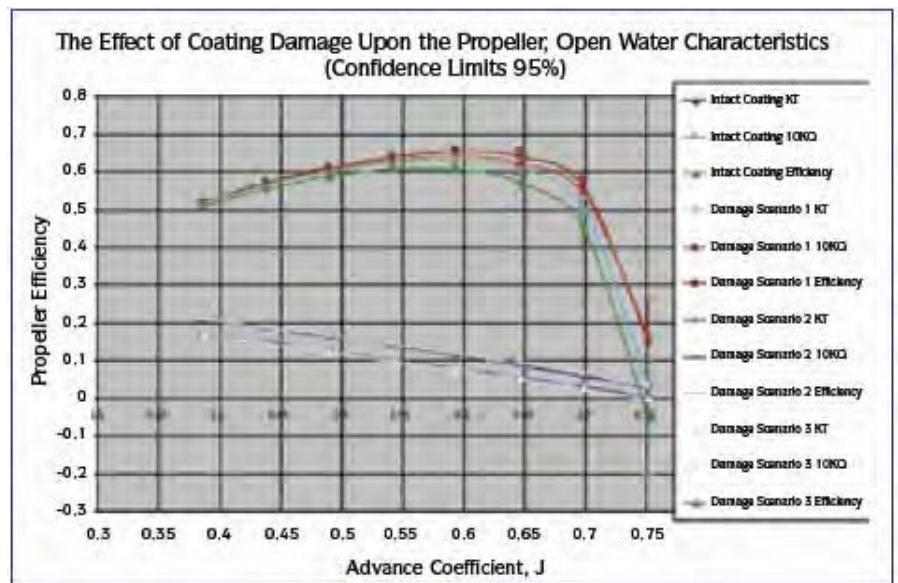
Figure 17: A comparison of the changes in open water characteristics with progressive damaged scenarios.

This loss of thrust would suggest that the damage to the coating is disturbing the flow past the propeller. It can also be seen that the maximum efficiency remains above 60% for all of the damage scenarios. The maximum damage generates less than a 5% loss in maximum propeller efficiency between the intact coating and the worst damage scenario.

These results suggest that damage to the propeller coating does not lead to large losses in efficiency, even when the damage is quite severe.

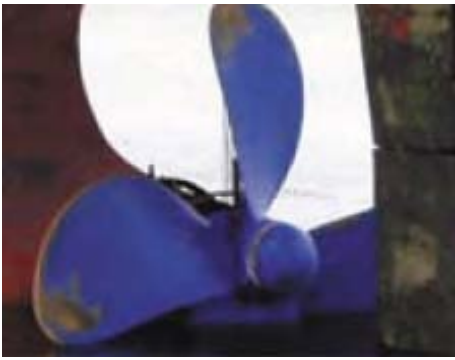
Figure 18: The full scale propeller after 37 months of service

Figures 18 and 19 show the full scale coating on the basis propeller after a period in service of 37 months. This shows that about 90% of the coating is still attached to the propeller despite some losses round the tip and the leading and trailing edges. It can also be seen that little or no fouling is present on the blades (the prop had not been cleaned during the 37 months in service). This shows that the coatings are able to prevent the build up of fouling and its associated increases in drag for extended periods (to date coatings have been trial led successfully for periods of over 3.5 years).

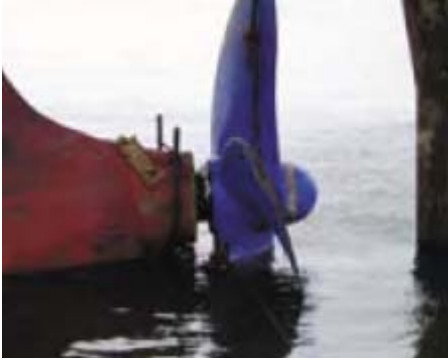
Figure 19: The back of the full scale propeller after 37 months of service.
